# Manhole Inspection Summary

Manhole # S21W\_\_026MH

Insp Date: **11/11/08 12:27 PM**

**Location** Address: **1931 HOLLINS FERRY RD**

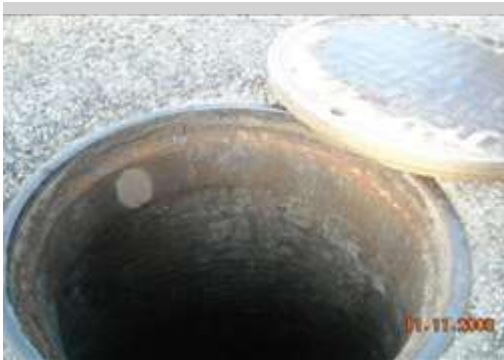
Defect

Subject To Ponding: **Sheeting**

☒ **Leaks**

FRAME LEAKS-INFLOW EVIDENCE  
FROM SHEETING

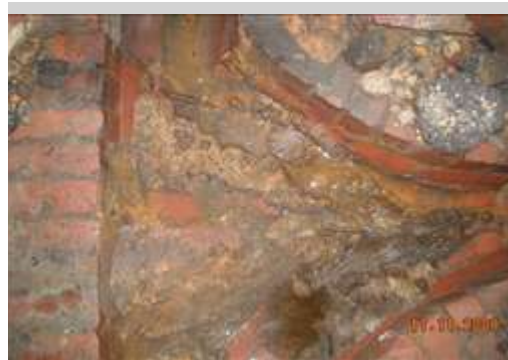
Defect 2

☒ **Debris**

DEBRIS IN CHANNEL

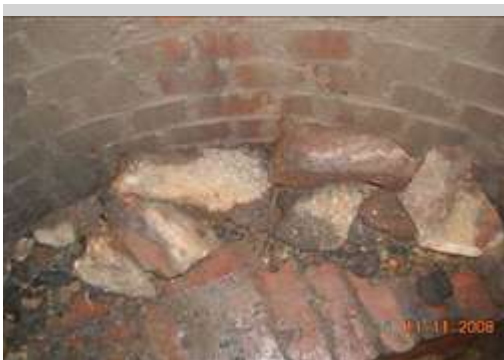
Defect 1

☒ **Debris**

DEBRIS ON BENCH

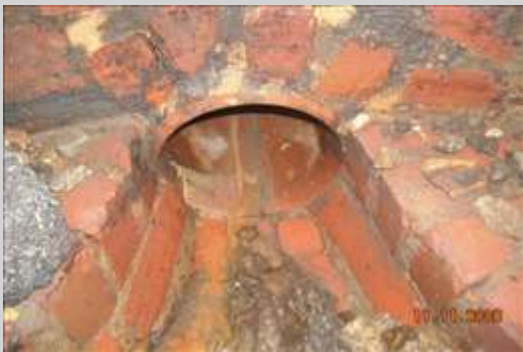
12 O'Clock Outflow

Pipe Height: **8.4** (in.) Rod and Bar (Angled)  
Pipe Material: **Clay** ☐ Pipe Lined  
Invert Depth: **8.50** (ft.) Flow Characteristics: **Slow**  
Deposits: ☒ None ☐ Mud ☐ Sludge ☐ Debris ☐ Grease  
Silt Depth: **0** (in.) Deposits Extent:  
Infiltration: **None** Pipe Seal Cond: **Sound**

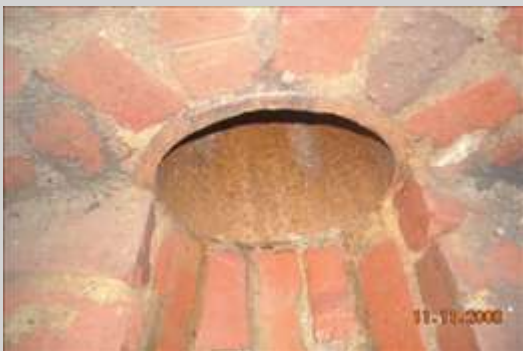
3 O'Clock Inflow

Pipe Height: **8.4** (in.) Rod and Bar (Angled)  
Pipe Material: **Clay** ☐ Pipe Lined  
Invert Depth: **7.90** (ft.) Flow Characteristics: **None**  
Deposits: ☒ None ☐ Mud ☐ Sludge ☐ Debris ☐ Grease  
Silt Depth: **0** (in.) Deposits Extent:  
Infiltration: **None** Pipe Seal Cond: **Sound**

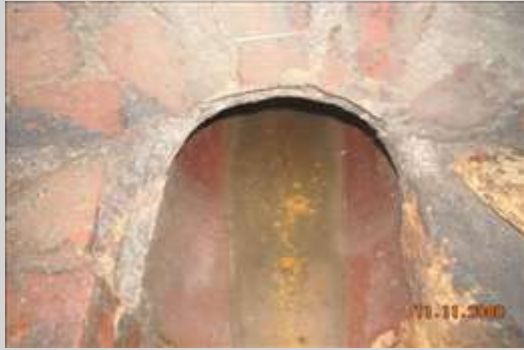
9 O'Clock Inflow

Invert Depth: **8.23** (ft.) Flow Characteristics: **Slow**

Infiltration: **None** Pipe Seal Cond: **Sound**
